TECHNIQUES OF FINAL PRESEAL VISUAL INSPECTION

By Robert J. Anstead
Goddard Space Flight Center

NATIONAL AERONAUTICS AND SPACE ADMINISTRATION
Washington, D.C.

1975

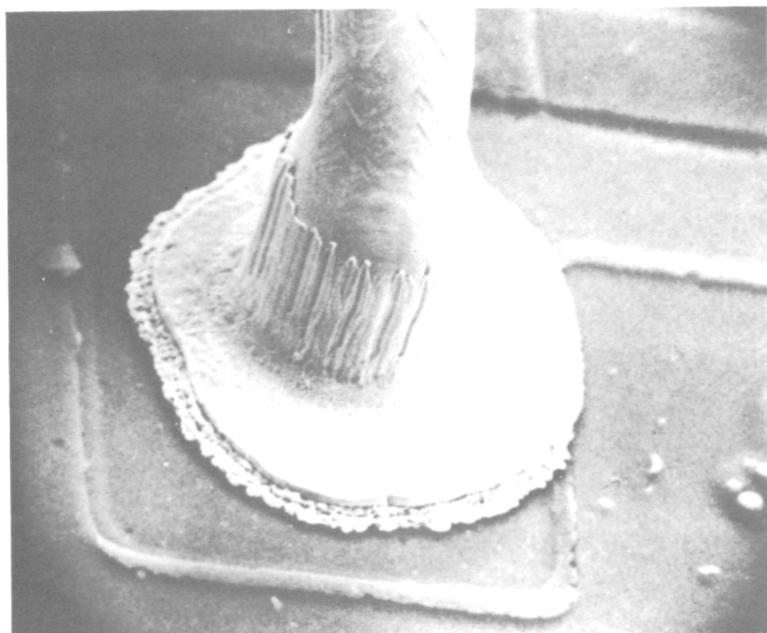
Figure 24. Scanning electron microscope photographs of typical wire bonds. (a) Proper gold ball bond (but considerable intermetallic formation is present); (b) Overbonded gold ball bond.
